**Reconstruction and Expansion of Route I-495/Route 1A
Wrentham, Massachusetts
Request for Determination of Applicability**

MassDOT Project #603739

July 6, 2022

RE: Request for Determination of Applicability
MassDOT I-495 and Route 1A Reconstruction Project
Wrentham, Massachusetts

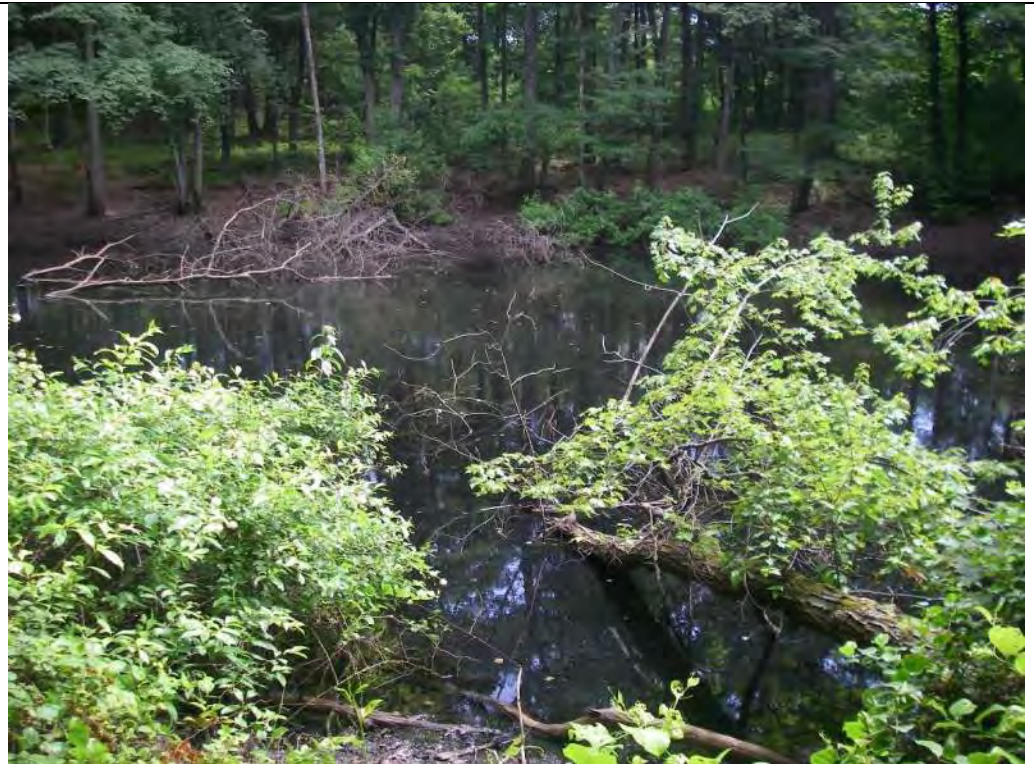
Photo No. 4	Date: 7/16/2019
----------------	--------------------

Description:
View of Wetland 3.

Wetland 3 was delineated as an open water/ponded feature located just south of the driveway to PW Preseton industrial facility, located off the western shoulder of Route 1A. The mean annual high water (MAHW) line of the pond was delineated with flagging labeled as W3-1 through W3-10. At delineation flag W3-9, an inlet to a 24-inch ductile iron culvert was observed to drain southward, connecting with Intermittent Stream 1 at delineation flag IS1-1.

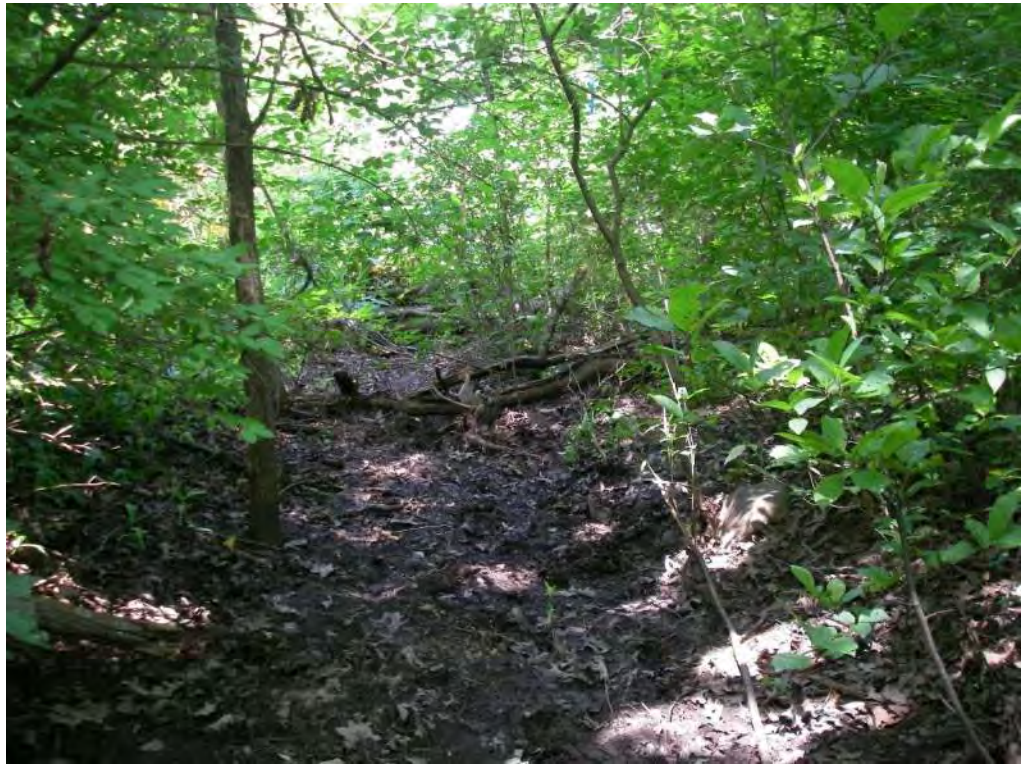
Description:
View of Intermittent Stream
1.

Intermittent Stream 1 was delineated south of Wetland 3, originating from the outlet of the 24-inch ductile iron culvert pipe and continuing southward then eastward underneath Route 1A. Intermittent Stream 1 was observed to enter a separate 24-inch ductile iron culvert pipe that crosses underneath Route 1A at delineation flag IS1-19 and outlets east of Route 1A at delineation flag IS1-20; the stream was then observed to extend northeastward outside the Project limits. The eastern/northern Bank of Intermittent Stream 1 was delineated, as the Project limits are located northeast/north of the stream. The western/southern Bank was not delineated, as this polyline was observed to be well outside the Project limits and the resource areas (i.e. Riverfront Area) extend into the Site from the eastern Bank and not the western. Intermittent Stream 1 was observed to vary in width with most of the stream (the portion located west of Route 1A) observed to be approximately three feet in width; the east side of Route 1A was observed to vary between 8-12 feet in width. During the time of delineation, no surficial flow was observed within the stream, but indicators of inundation were observed and the MAHW was flagged and surveyed appropriately as Bank.

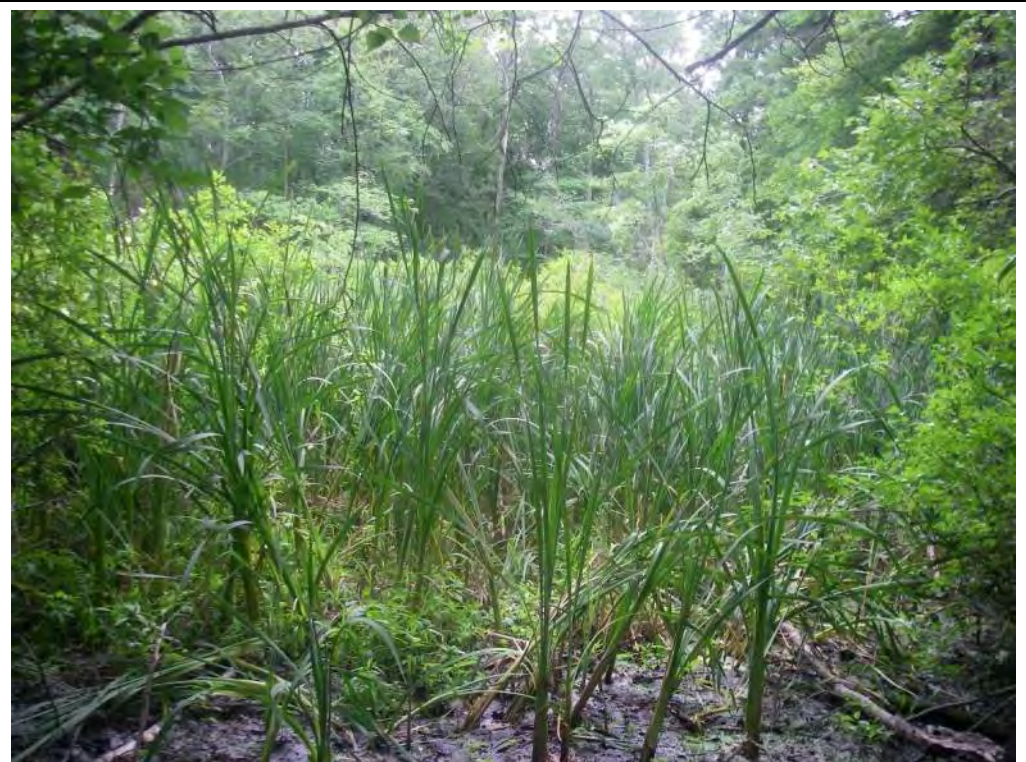
Photo No.
8

Description:
View of Wetland 4.

Wetland 4 was delineated in the eastern portion of the Site. This wetland was observed to continue both eastward, as well as southward from the delineated boundaries. Wetland 4 was observed to be predominantly vegetated with swamp white oak, red osier dogwood (*Cornus sericia*), and cattails (*Typha angustifolia*). Hydrological indicators of wetland conditions included inundation of approximately two-inches, high water table, saturation, sediment deposits, hydrogen sulfide odor, thin muck surface and drainage patterns. Soils were observed to be an organic silt with a 10YR2/1 matrix color in the A-horizon (0-6") and a silty clay loam with a 10YR 3/2 matrix (80%) and 10YR 3/4 mottle (20%) color in the B-horizon (6-24"). Soils were observed to meet both the hydrogen sulfide (A4) and thin dark surface (S9) hydric soil criteria. Wetland 4 was also observed to contain a mapped CVP and PVP located just east of the Project boundaries, but still within the same wetland complex.

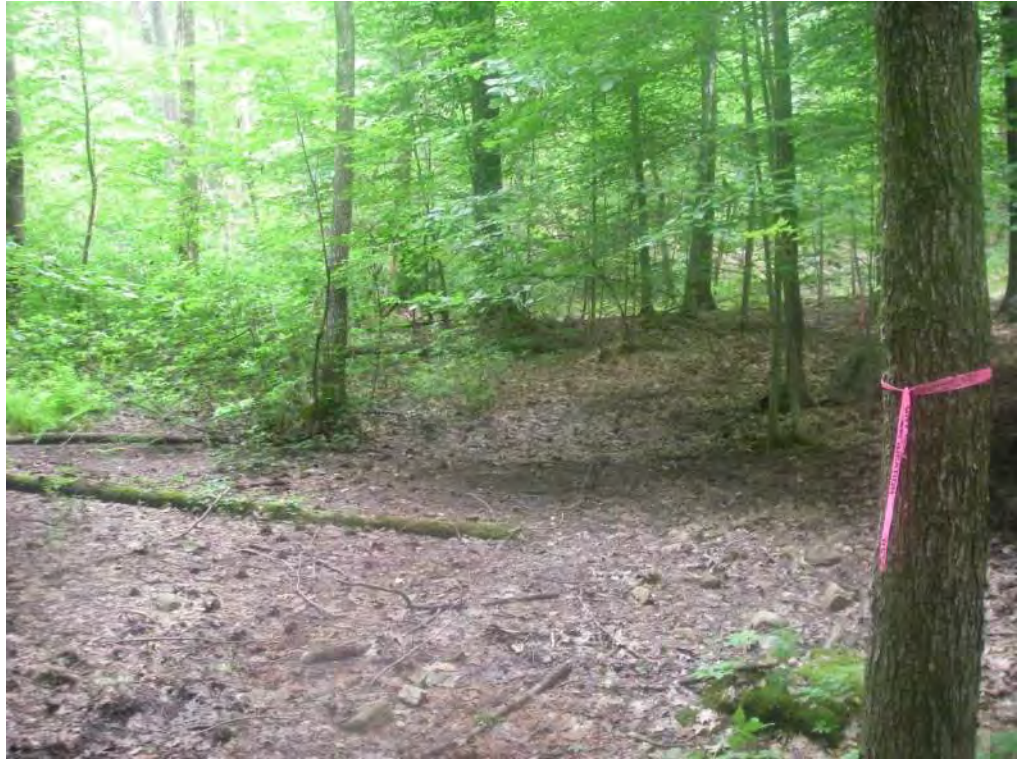
Description:
View of eastern portion of
Wetland 5.

Wetland 5 was delineated northeast of the I-495 southbound exit ramp. This wetland was observed to contain a mapped PVP. The eastern portion of the wetland was observed to contain a small, less than 40-foot in diameter inundated depression area/pool that was shaded by larger tree species (greater than 8-inch diameter at breast height). The western portion of the wetland was observed to be more flatly sloped, saturated, and with little shading from the larger hydrophytic tree species. Two data points were taken within the differentiating areas of the same wetland; data point 5 (eastern portion) and data point 6 (western portion). Wetland 5 was observed to be predominately vegetated with silver maple, red maple (*Acer rubrum*), green ash (*Fraxinus pennsylvanica*), and jewelweed (*Impatiens capensis*). Hydrological indicators of wetland conditions included high water table, saturation, inundation visible on aerial imagery, water-stained leaves and stunted or stressed plants. Soils in the eastern portion of the wetland were observed to meet the dark surface (S7) criteria, while the western portion were observed to meet the depleted matrix (F3) criteria.

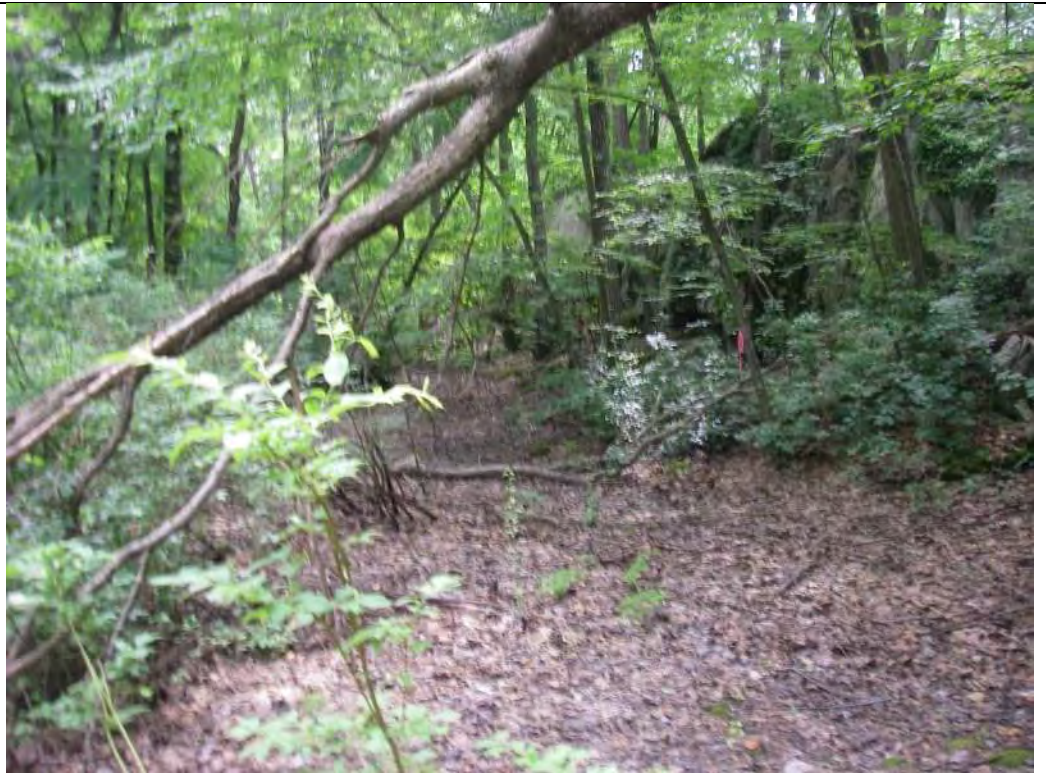
Photo No. 14	Date: 7/17/2019
-----------------	--------------------

Description:
View of Wetland 6.

Wetland 6 was delineated northeast of the eastern portion of the Site and was observed to be a depression area (less than 12,000 square feet in size) located at the toe of a rock outcropping. This wetland was observed to contain a mapped CVP and PVP, but no inundation was observed within this wetland during the time of delineation. Wetland 6 was observed to be predominantly vegetated with silver maple, green ash and sensitive fern. Hydrological indicators of wetland conditions included saturation present at a depth of approximately eight-inches below grade, inundation visible on aerial imagery, water-stained leaves and surface soil cracks. Soils were observed to be a silty clay loam with a 10YR 2/2 matrix color in the A-horizon (0-6") and a silty clay loam with a 10YR 4/2 (90%) and 10YR 4/4 mottle (10%) color in the B-horizon (6-24"). Soils were observed to meet the depleted matrix (F3) hydric soil criteria.
